**[Docket No. FAA-2016-4674; Directorate Identifier 2016-SW-001-AD; Amendment 39-18835; AD 2017-06-11]**

**Airworthiness Directives; Airbus Helicopters**

**ACTION:** Final rule; request for comments.

2017-06-11 **Airbus Helicopters:** Amendment 39-18835; Docket No. FAA-2016-4674; Directorate Identifier 2016-SW-001-AD.

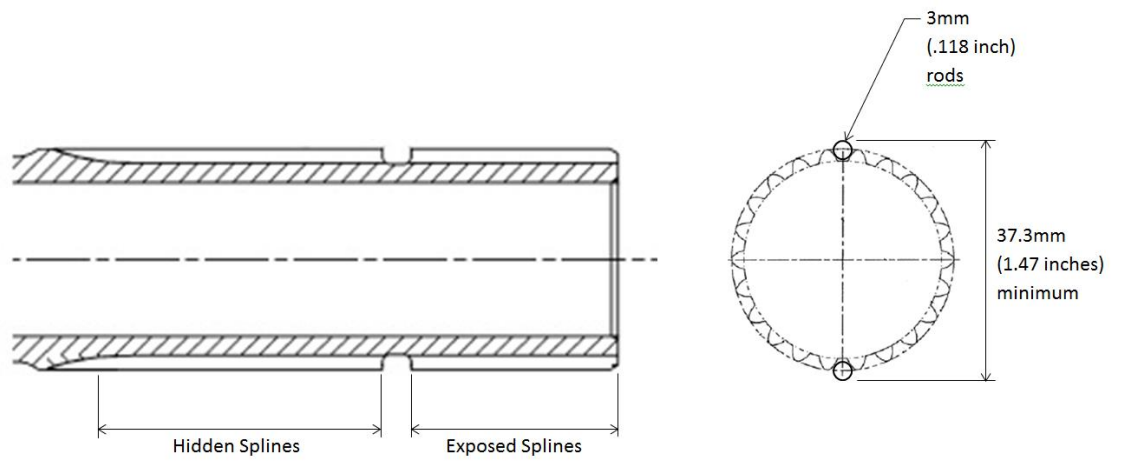
(ii) Inspect the exposed portion of each wheel spline for cracking, scoring, metal pick-up, and wear by using Figure 1 to paragraph (f)(1)(ii) of this AD. To inspect for wear, position two 3 mm (0.118 inch) rods in all diametrically opposed splines and measure to determine whether there is a minimum of 37.3 mm (1.47 inches) across the outside diameter of the rods. If there is any cracking, scoring or metal pick-up, or if a measurement is less than 37.3 mm, replace the wheel.
